HISTORIC RESOURCES INVENTORY

BUILDINGS AND STRUCTURES

STATE OF CONNECTICUT
CONNECTICUT HISTORICAL COMMISSION
 59 SOUTH PROSPECT STREET, HARTFORD, CONNECTICUT 06106
 (203) 566-3005

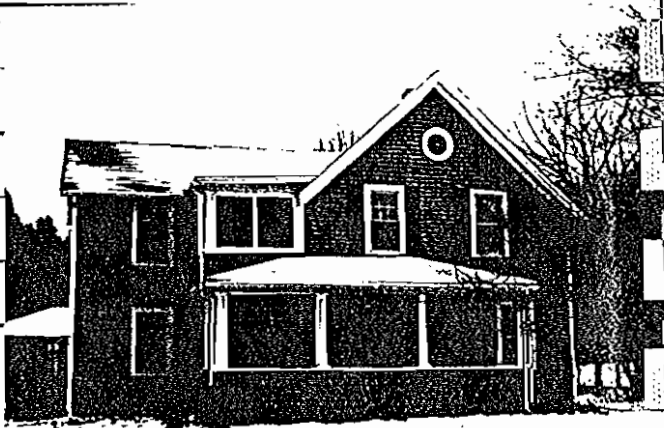
| 12. CONDITION (Structural) | | (Exterior) | |
| <input type="checkbox"/> Excellent | <input checked="" type="checkbox"/> Good | <input type="checkbox"/> Fair | <input type="checkbox"/> Deteriorated |

31 Gardner Street is an attractive two-story vernacular gable-and-wing-type frame residence with a gable roof, oriented with the principal gable end to the street. The structure rests on a brick foundation and is sheathed with clapboards. The building incorporates an offset entry (front/right) and full-width porch with Tuscan half-columns and shingled solid balustrade. Window sash is of 6/1 configuration arranged in a two-bay facade. Architectural features include a two-story gabled ell on the left and circular window in the gable peak.

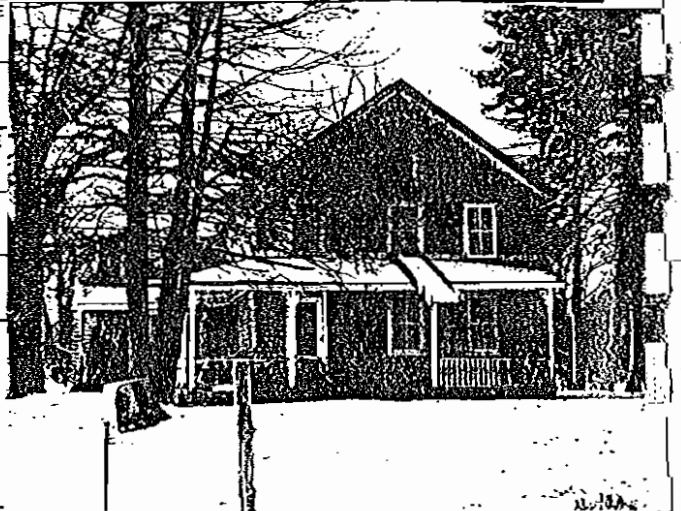
176 Gardner Street is a substantial two-story vernacular frame dwelling with a gable roof, oriented with the gable end to the street. The structure rests on a brick foundation and is sheathed with wood shingles. The building incorporates an offset entry (front/left) and wraparound porch with turned columns and balusters and sawn brackets. Window sash is of 6/6 configuration arranged in a three-bay facade. Architectural features include 6/6 sash with molded entablature in the gable peak and a two-story gabled wing at the left/rear.

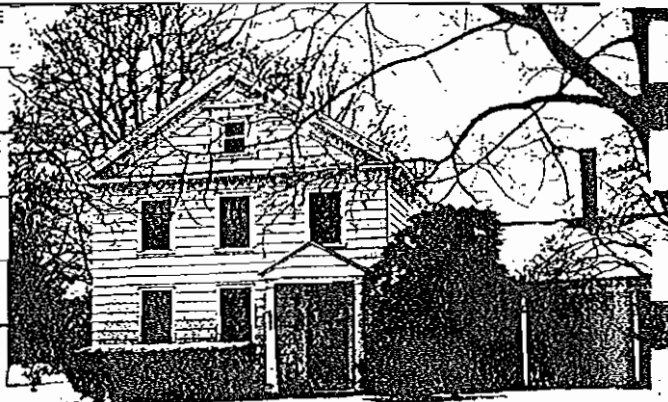
187 Gardner Street is a simple two-story Greek Revival-style frame residence with a gable roof, oriented with the gable end to the street. The structure rests on a stone foundation and is sheathed with replacement asbestos siding. The building incorporates an offset entry (front/right) with pilaster-and-lintel surround and gabled entry porch with tapered square columns. Window sash is of 6/6 configuration arranged in a balanced three-bay facade. Architectural features include a pedimented gable with square window surmounted by a prominent molded entablature and single-story gabled wing with full-width porch on the right.

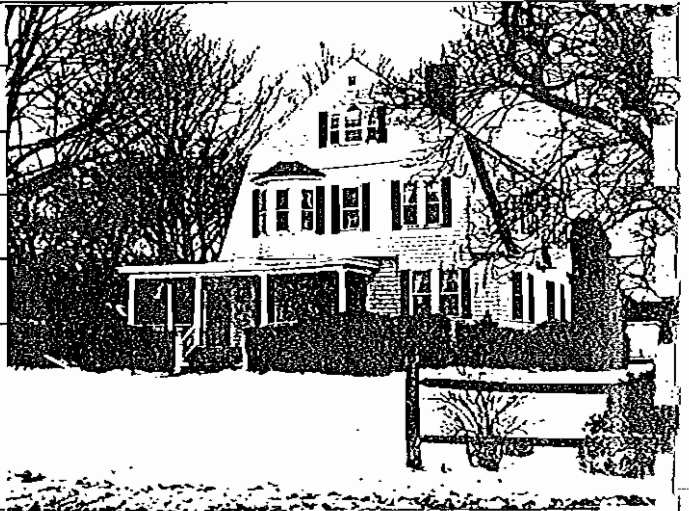
241 Gardner Street is a handsome two-story Shingle-style frame residence with a gambrel roof, oriented with the gable end to the street. The structure rests on a brick foundation and is sheathed with wood shingles. The building incorporates an offset entry (front/left) and wraparound porch with Tuscan columns. Window sash is of mixed configuration. Architectural features include a one-story gabled ell in the rear, central chimney, shed dormer on the left, second-story bay window at the front left, and two bay windows on the right beneath shallow shed dormers.

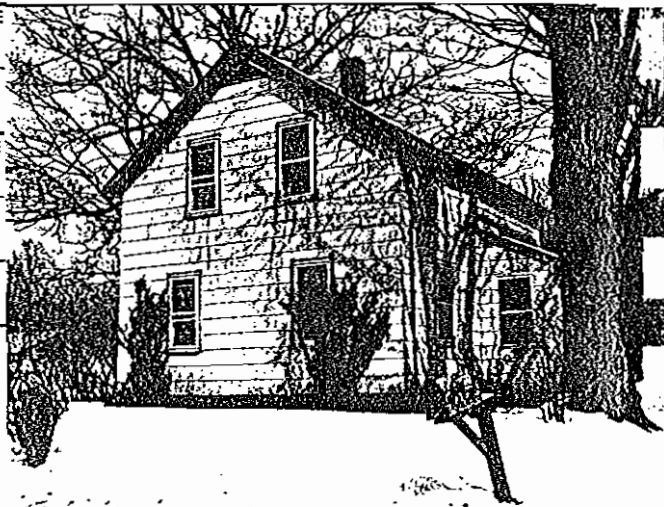
433 Gardner Street is a very simple two-story vernacular frame dwelling with a gable roof, oriented with the gable end to the street. The structure rests on a brick foundation and is sheathed with replacement asbestos siding. The building incorporates a side entry and enclosed shed-roofed entry porch. Window sash is of 1/1 configuration arranged in a two-bay facade.

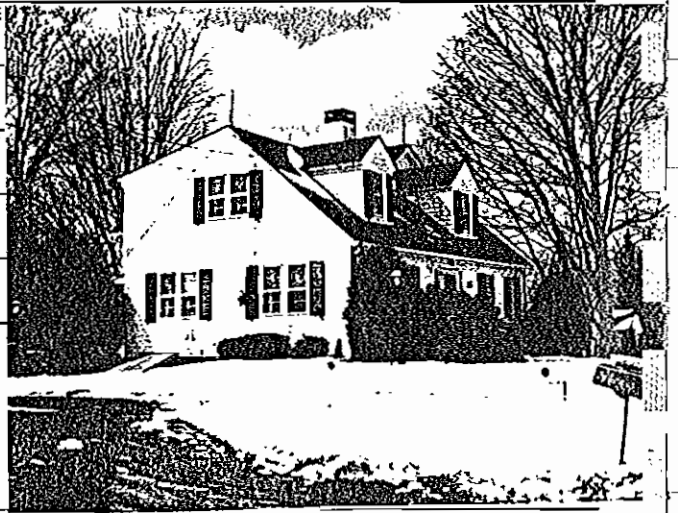
516 Gardner Street is a much expanded 1-1/2-story Cape Cod-style frame dwelling with a gable roof, oriented with the long elevation to the street. The structure rests on a stone foundation and is sheathed with wood shingles. The building incorporates a central entry with sidelights and simple pilasters. Window sash is of 2/2 configuration arranged in a five-bay facade. Architectural features include a full-width shed dormer in the rear, central chimney, two gable dormers in the street elevation, and several later additions at the side and rear.

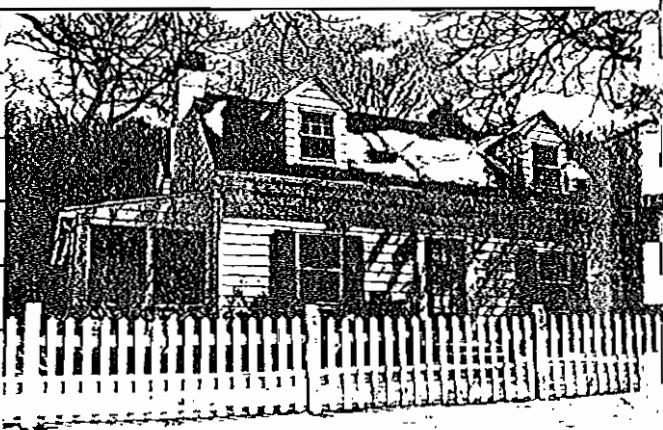
569 Gardner Street is an attractive 1-1/2-story Cape Cod-style frame dwelling with a gable roof, oriented with the long elevation to the street. The structure rests on a concrete foundation and is sheathed with wood shingles. The building incorporates a central entry and nicely molded pilaster-and-lintel surround. Window sash is of 8/8 configuration arranged in a two-bay facade. Architectural features include an external chimney on the left, enclosed shed-roofed porch on the left, two gable dormers in the street elevation, and dentil course at the eaves.

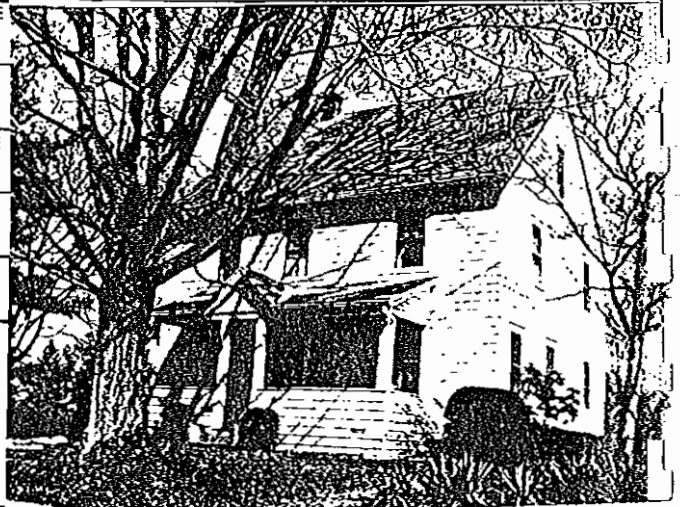
29 Griswold Street is a simple but substantial two-story vernacular frame residence with a gable roof, oriented with the long elevation to the street. The structure rests on a concrete foundation and is sheathed with replacement asbestos siding. The building incorporates a central entry and large entry porch with gabled entry peak, square half-columns, and solid balustrade. Window sash is of 2/2 configuration arranged in a balanced three-bay facade.

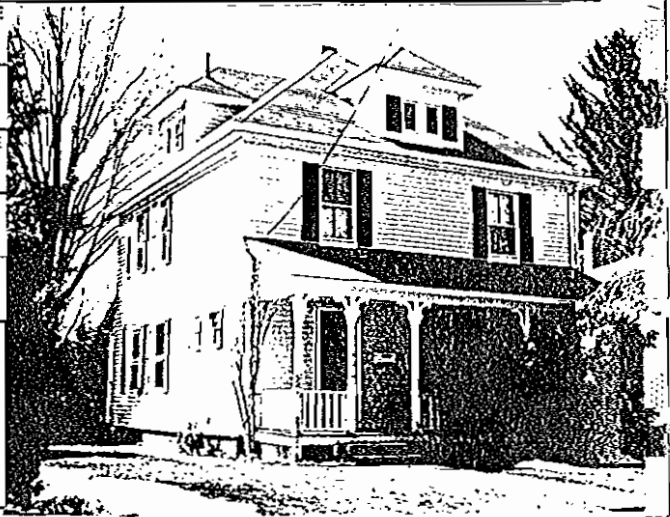
36 Griswold Street is an attractive two-story Foursquare-type frame dwelling with a hip roof. The structure rests on a brick foundation and is sheathed with replacement vinyl siding. The building incorporates an offset entry (front/left) and full-width shed-roofed porch with turned columns and sawn brackets. Window sash is of 2/2 configuration arranged in a two-bay facade. Architectural features include hip-roofed dormers in the left, right, and street elevations.

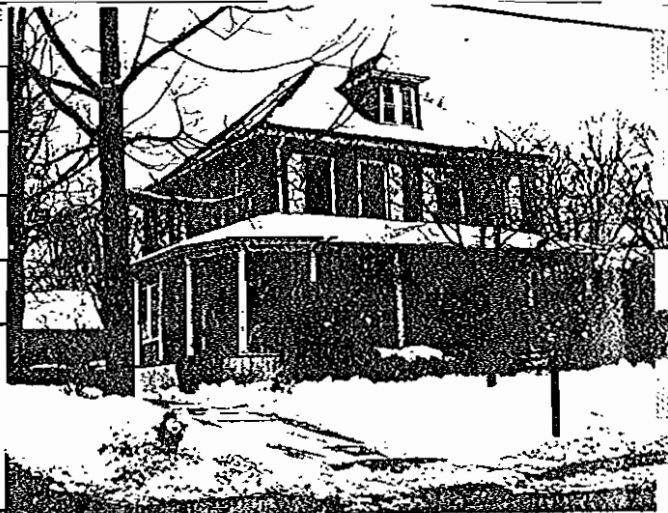
8 Hackmatack Street is an attractive and substantial two-story Foursquare-style frame residence with a hip roof. The structure rests on a brick foundation and is sheathed with clapboards. The building incorporates an offset entry at front-right and wraparound porch with Tuscan columns. Window sash is of 1/1 configuration arranged in a four-bay facade. Architectural features include a hipped dormer in the street elevation.

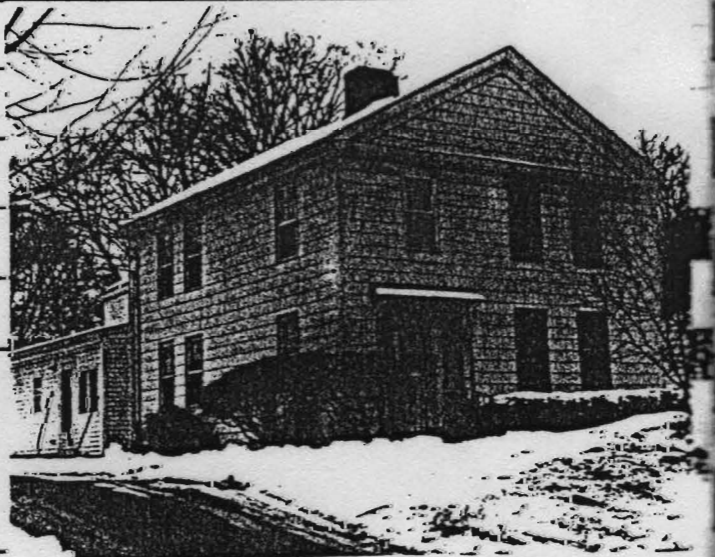
14 Hackmatack Street is a simple two-story Greek Revival-style frame residence with a gable roof, oriented with the gable end to the street. The structure rests on a stone foundation and is sheathed with replacement aluminum siding. The building incorporates an offset entry at front/left with sidelights and pilaster-and-lintel surround. Window sash is of 6/6 configuration arranged in a three bay facade. Architectural features include a pedimented gable and 1-1/2-story gable-roof ell in the rear.

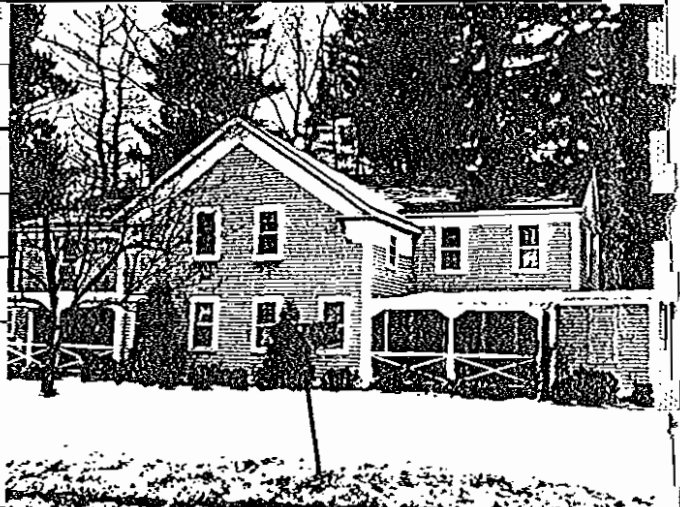
15 Hackmatack Street is an interesting 1-1/2-story vernacular Greek Revival-style two-family frame residence with a gable roof, oriented with the gable end to the street. The structure rests on a brick foundation and is sheathed with clapboards. The building incorporates offset entries on the right and left and small shed-roofed entry porches. Window sash is of 6/6 configuration arranged in a four-bay facade. Architectural features include large two-story gable-roofed wings on the right and left, wide frieze and rake boards, and molded eaves/returns.

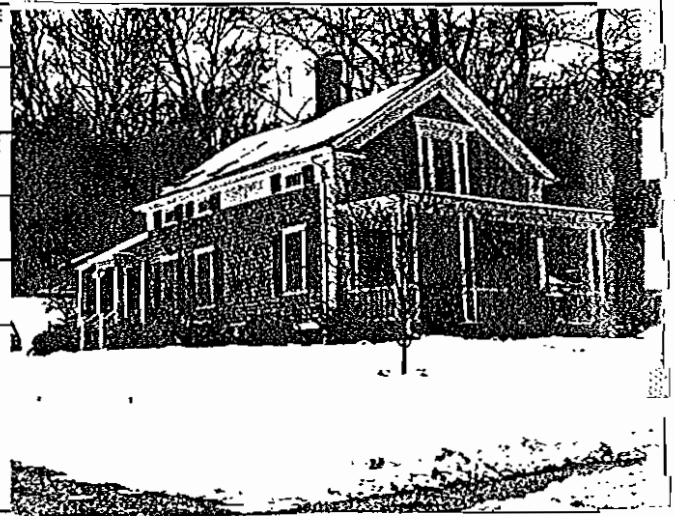
| <input type="checkbox"/> Excellent | <input checked="" type="checkbox"/> Good | <input type="checkbox"/> Fair | <input type="checkbox"/> Deteriorated | <input type="checkbox"/> Excellent | <input checked="" type="checkbox"/> Good | <input type="checkbox"/> Fair | <input type="checkbox"/> Deteriorated |

78 Hackmatack Street is a much-altered 1-1/2-story nineteenth-century vernacular cottage with a gable roof, oriented with the long elevation to the street. The structure rests on a brick foundation and is sheathed with replacement asbestos siding. The building incorporates a central entry and enclosed entry porch. Window sash is of 6/6 configuration. Architectural features include exposed rafter tails, small shed-roofed addition on the right, and a 1-1/2-story gable-roofed ell in the rear.

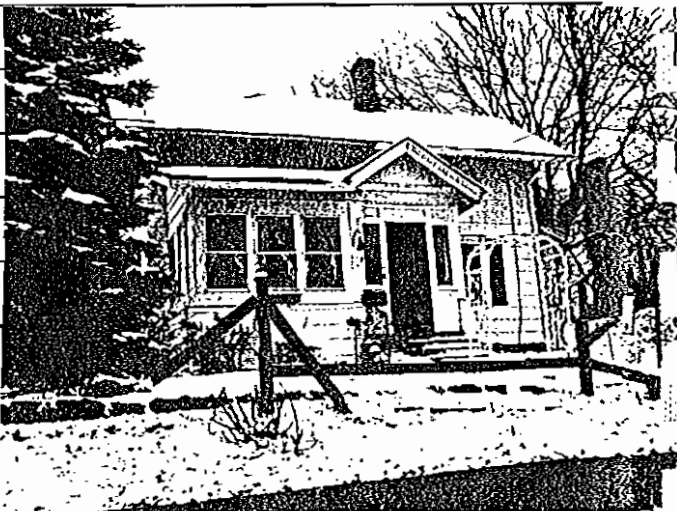
| <input type="checkbox"/> Excellent | <input checked="" type="checkbox"/> Good | <input type="checkbox"/> Fair | <input type="checkbox"/> Deteriorated | <input type="checkbox"/> Excellent | <input checked="" type="checkbox"/> Good | <input type="checkbox"/> Fair | <input type="checkbox"/> Deteriorated |

84 Hackmatack Street is a much altered 1-1/2-story Cape Cod-style dwelling with a gable roof, oriented with the long elevation to the street. The structure rests on a brick foundation and is sheathed with replacement vinyl siding. The building incorporates a central entry and full-width porch with square columns, surmounted by a balustraded sundeck. Window sash is of 6/6 configuration arranged in a five-bay facade. Architectural features include an external chimney on the left and three gable dormers in the street elevation, the center gable being far larger than its flanking neighbors.

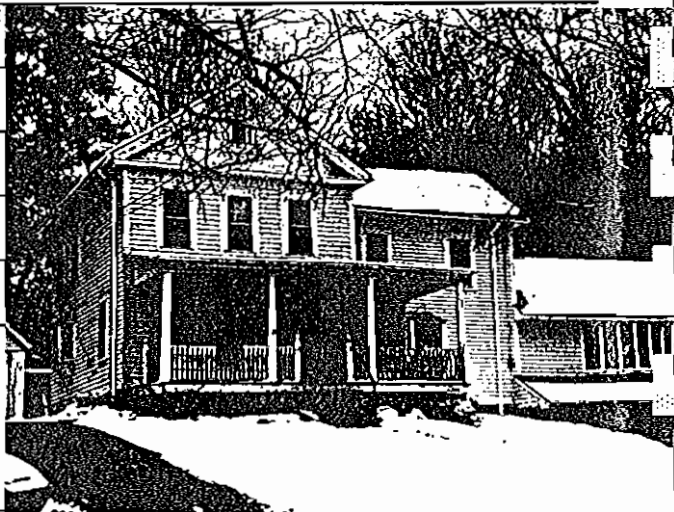
183 Hackmatack Street is a simple two-story vernacular gable-and-wing frame residence with a gable roof, oriented with the principal gable to the street. The structure rests on a brick foundation and is sheathed with wood shingles. The building incorporates an offset entry (right) and enclosed shed-roofed entry porch. Window sash is of 2/2 configuration arranged in a two-bay facade. Architectural features included molded eaves/returns and a two-story gable-roofed wing on the right.
