**HISTORIC AND ARCHITECTURAL
RESOURCE SURVEY
OF
MANCHESTER, CONNECTICUT**

(Vol. II)

**Prepared for the
Manchester Planning Department
and
Connecticut Historical Commission**

April 1998

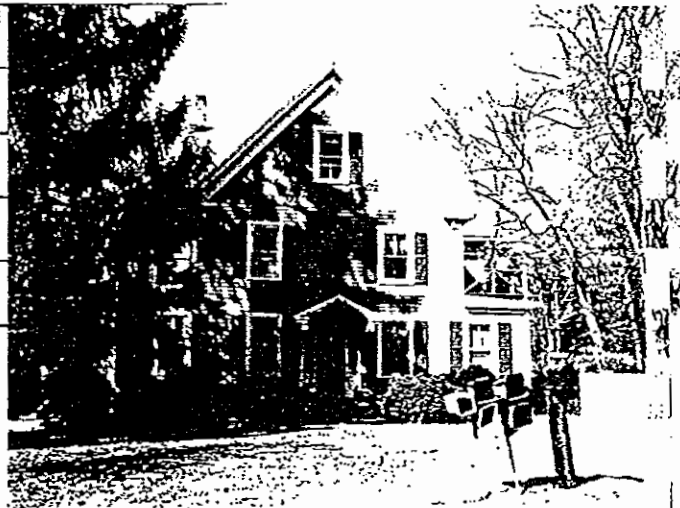
IDENTIFICATION	1. BUILDING NAME (Common) _____ (Historic) _____	
	2. TOWN / CITY Manchester	VILLAGE _____ COUNTY Hartford
	3. STREET AND NUMBER (and / or location) 213-215 Highland Street

11. NUMBER OF STORIES 2	APPROXIMATE DIMENSIONS 40- x 38'	
12. CONDITION (Structural) _____ (Exterior) _____		
<input type="checkbox"/> Excellent <input checked="" type="checkbox"/> Good <input type="checkbox"/> Fair <input type="checkbox"/> Deteriorated	<input type="checkbox"/> Excellent <input checked="" type="checkbox"/> Good <input type="checkbox"/> Fair <input type="checkbox"/> Deteriorated

213-215 Highland Street is an attractive and substantial two-story vernacular frame two-family residence with a gable roof, oriented with the long elevation to the street. The structure rests on a brick foundation and is sheathed with clapboards and wood shingles. The building incorporates a central entry with sidelights and a gabled entry hood supported by stout brackets. Window sash is of 2/2 configuration arranged in a two-bay facade. Architectural features include simple eaves returns, decorative shinglework in the gable peaks, two-story gabled ell in the rear, and a very large two-story cross-gable centered in the street elevation. At the intersections of the street facing cross-gable and the main block of the house are located two single-story enclosed porches surmounted by small sunporches.

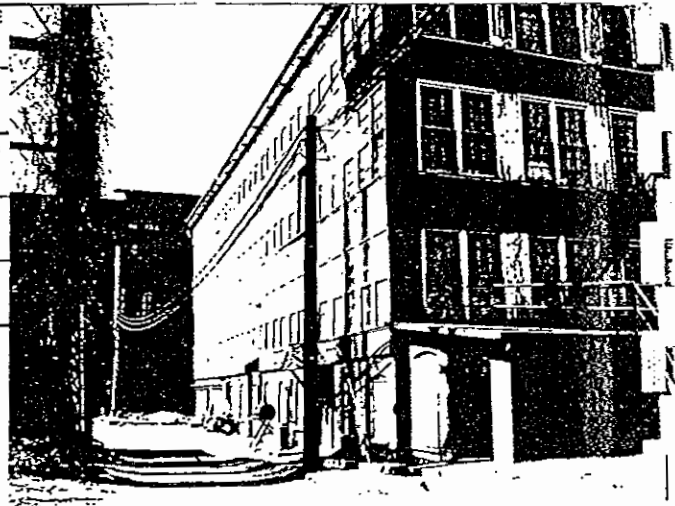
12. CONDITION (Structural)		<i>(Exterior)</i>	
<input type="checkbox"/> Excellent	<input checked="" type="checkbox"/> Good	<input checked="" type="checkbox"/> Fair	<input type="checkbox"/> Deteriorated
		<input type="checkbox"/> Excellent	<input checked="" type="checkbox"/> Good
		<input checked="" type="checkbox"/> Fair	<input checked="" type="checkbox"/> Deteriorated

596-642 Hilliard Street is a sprawling former mill complex consisting of brick masonry and frame buildings ranging from one to three stories in height. The principal structure consists of a three-story rectangular frame building on a raised foundation with continuous 9/9 sash set beneath segmental arch lintels. At the west end of this building stands a large later three-story brick-pier type structure on concrete foundation, utilizing industrial metal multipane sash with flat sills. The building is 15 bays long. This portion of the mill incorporates an entry with simple molded-concrete classical surround. The adjacent boiler house, a deteriorating square brick structure, is marked by the very substantial tapered square chimney. The site also contains several other smaller one- and two-story structures of both frame and masonry construction with shallow gable roofs.

In 1901 the firm acquired the waterpower rights of the (then defunct) Peter Adams Paper Company and installed an electrical generator. At this time Hilliard employed 180 workers; in the 1920s more than 200 employees were on the payroll, turning out men's and women's wear, woolens, and overcoatings. Surviving facilities on this site, some in marked disrepair, include the c. 1834 mill and two-story c. 1870 pickers house measuring 41 x 30, as well as substantial frame and brick mill buildings erected in 1896 (frame, 3-story 119'x59'), 1909 (brick, 1-story, 101'x49'), and 1925 (brick, 3-story, trapezoidal plan measuring 77' x 197' x 82' x 231'). In January 1935 in the depths of the Depression the workers went on strike, causing a temporary closing of the mill the following March. In 1941 E. E. Hilliard Company closed permanently. The former mill buildings, some derelict, some partially occupied, nonetheless comprise an important historic industrial site, one of the oldest in eastern Connecticut.

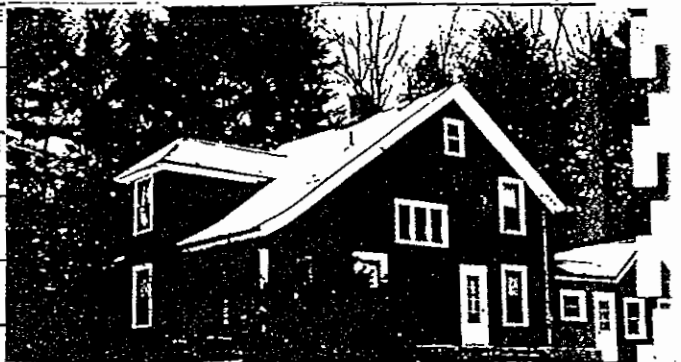
11. NUMBER OF STORIES 1-1/2	APPROXIMATE DIMENSIONS 26' x 34'		
12. CONDITION (Structural)		(Exterior)	
<input type="checkbox"/> Excellent <input checked="" type="checkbox"/> Good <input type="checkbox"/> Fair <input type="checkbox"/> Deteriorated	<input type="checkbox"/> Excellent <input checked="" type="checkbox"/> Good <input type="checkbox"/> Fair <input type="checkbox"/> Deteriorated

4 Hills Street is a simple 1-1/2-story "Bungaloid" frame residence with a gable roof, oriented with the long elevation to the street. The structure rests on a concrete foundation and is sheathed with wood shingles. The building incorporates an offset entry (right) and integral corner porch with square half-columns. Window sash is of 1/1 configuration. Architectural features include an unusual two-story hip-roofed bay window/dormer in the center of the street elevation and a small gabled ell in the rear.

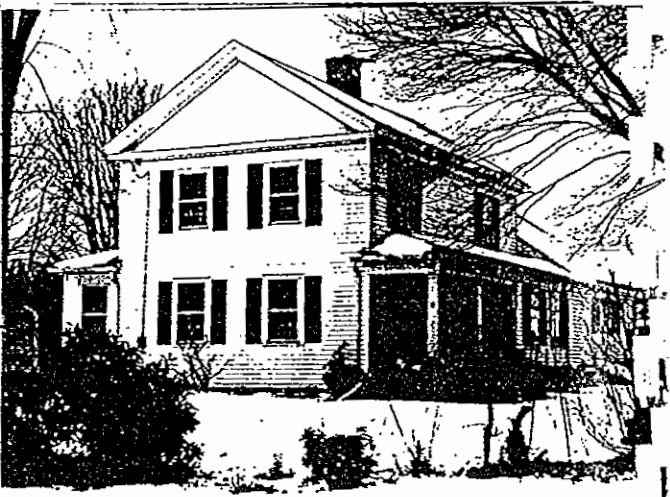
11. NUMBER OF STORIES <u>2</u>	APPROXIMATE DIMENSIONS <u>20' x 30'</u>	
12. CONDITION (Structural)		
<input type="checkbox"/> Excellent	<input checked="" type="checkbox"/> Good	
<input type="checkbox"/> Fair	<input type="checkbox"/> Deteriorated	
(Exterior)		
<input type="checkbox"/> Excellent	<input checked="" type="checkbox"/> Good	
<input type="checkbox"/> Fair	<input type="checkbox"/> Deteriorated

42 Hills Street is a substantial two-story Greek Revival-style frame residence with a gable roof, oriented with the gable end to the street. The structure rests on a stone slab foundation and is sheathed with replacement vinyl siding. The building incorporates an offset entry (right) and corner porch with stout Doric columns. Window sash is of 6/6 configuration arranged in a two bay facade. Architectural features include a pedimented gable, single-story hip-roofed addition on the left, and a 1-1/2-story gabled ell at the right/rear.

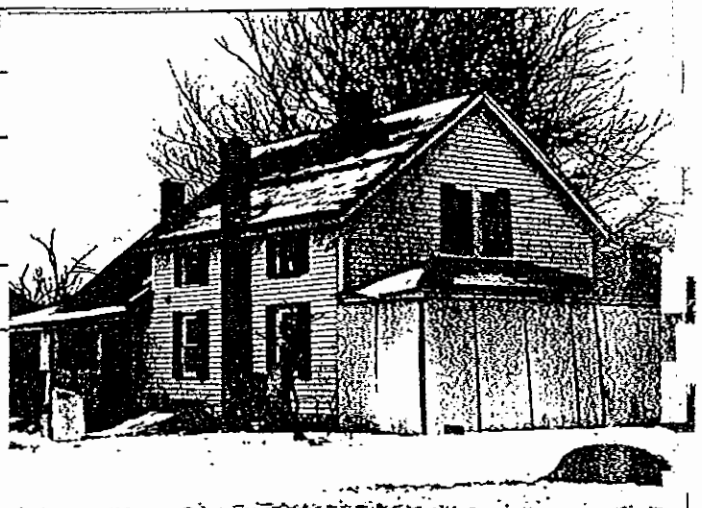
188 Hillstown Road is a simple 1-1/2-story vernacular cottage with a gable roof, oriented with the gable end to the street. The structure rests on a stone foundation and is sheathed with clapboards. The building incorporates a central entry and full-width hip-roofed porch with Tuscan half-columns and solid balustrade. Window sash is of 1/1 configuration. Architectural features include 3/1 frieze windows in the side elevations and a single-story gabled ell in the rear.

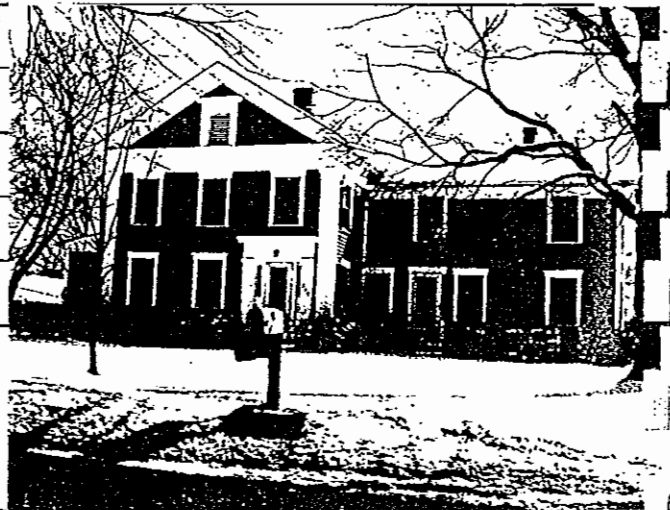
11. NUMBER OF STORIES	APPROXIMATE DIMENSIONS		
2	50' x 33'		
12. CONDITION (Structural)		(Exterior)	
<input type="checkbox"/> Excellent <input checked="" type="checkbox"/> Good <input type="checkbox"/> Fair <input type="checkbox"/> Deteriorated	<input type="checkbox"/> Excellent <input checked="" type="checkbox"/> Good <input type="checkbox"/> Fair <input type="checkbox"/> Deteriorated

269 Hillstown Road is a handsome and substantial two-story Greek Revival-style residence with a gable roof, oriented with the gable end to the street. The structure rests on a stone foundation and is sheathed with clapboards. The building incorporates an offset entry (right) and prominent pilaster-and-lintel surround. Window sash is of 1/1 configuration with a simple molded entablature arranged in a three-bay facade. Architectural features include a pedimented gable containing a large rectangular window with flat molded entablature, wide Doric corner pilasters, wide frieze, 1-1/2-story gabled wing on the right, central chimney, and later single-story shed-roofed addition on the left.

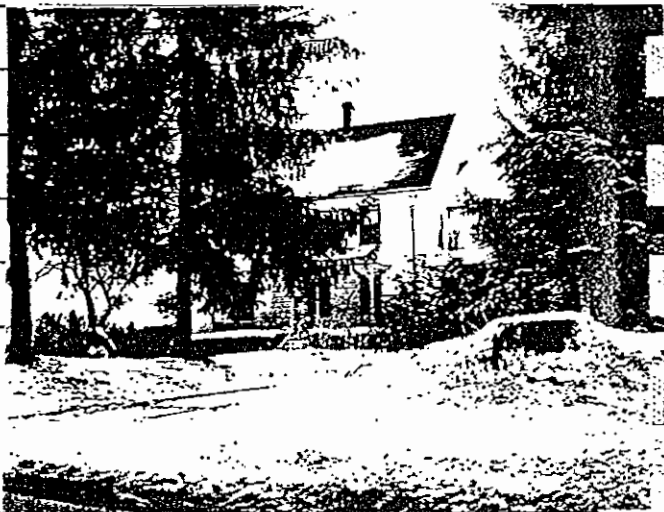
11. NUMBER OF STORIES	APPROXIMATE DIMENSIONS
2	48' x 28'
12. CONDITION (Structural) (Exterior)	
<input type="checkbox"/> Excellent <input checked="" type="checkbox"/> Good <input type="checkbox"/> Fair <input type="checkbox"/> Deteriorated	<input type="checkbox"/> Excellent <input checked="" type="checkbox"/> Good <input type="checkbox"/> Fair <input type="checkbox"/> Deteriorated

483 Hillstown Road is a substantial two-story vernacular frame residence with a combination half hip-half gable roof. The structure rests on a poured concrete foundation and is sheathed with replacement vinyl siding. The building incorporates a central entry and hip-roofed porch with turned columns and balusters and sawn brackets. Window sash is of 6/1 configuration. Architectural features include a two-story wing at the right/rear and a single-story hip-roofed enclosed porch at the right/front. A former tobacco barn also stands on the property.

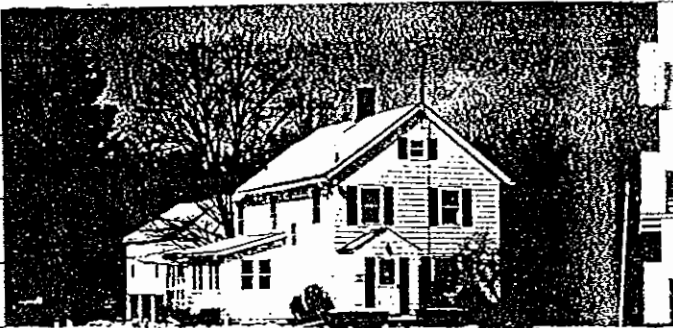
11. NUMBER OF STORIES		APPROXIMATE DIMENSIONS	
2		22' x 30'	
12. CONDITION (Structural) <i>(Exterior)</i>			
<input type="checkbox"/> Excellent	<input checked="" type="checkbox"/> Good	<input type="checkbox"/> Fair	<input type="checkbox"/> Deteriorated
<input type="checkbox"/> Excellent	<input checked="" type="checkbox"/> Good	<input type="checkbox"/> Fair	<input type="checkbox"/> Deteriorated

742 Hillstown Road is a simple two-story vernacular frame residence with a gable roof, oriented with the gable end to the street. The structure rests on a poured concrete foundation and is sheathed with replacement aluminum siding. The building incorporates an offset entry (left) and enclosed gabled entry porch. Window sash is of 1/1 configuration arranged in a two-bay facade. Architectural features include a single-story shed-roofed addition on the left, a two-story gabled ell in the rear, and a small central chimney.

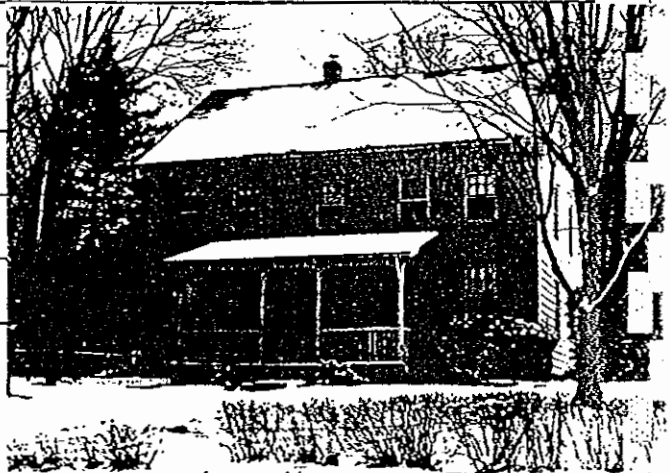
11. NUMBER OF STORIES	APPROXIMATE DIMENSIONS	
2	32' x 26'	
12. CONDITION (Structural)		(Exterior)
<input type="checkbox"/> Excellent	<input checked="" type="checkbox"/> Good	<input type="checkbox"/> Fair
<input type="checkbox"/> Deteriorated	<input type="checkbox"/> Excellent	<input checked="" type="checkbox"/> Good
	<input type="checkbox"/> Fair	<input type="checkbox"/> Deteriorated

99 Keeney Street is a substantial two-story New England Farmhouse-style frame residence with a gable roof, oriented with the long elevation to the street. The structure rests on a stone and brick foundation and is sheathed with wood shingles. The building incorporates a central entry with sidelights and flat pilaster-and-lintel surround, beneath a large shed-roofed entry porch. Window sash is of 6/6 configuration arranged in a five-bay facade. Architectural features include wide corner pilasters, eaves returns, and a wide frieze.

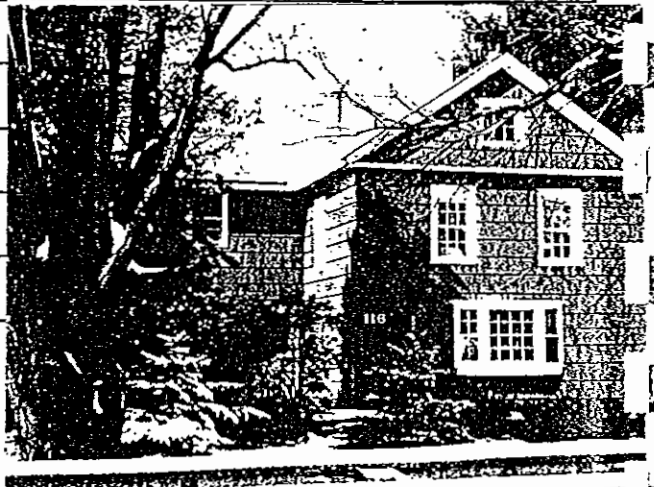
11. NUMBER OF STORIES 2	APPROXIMATE DIMENSIONS 40' x 38'	
12. CONDITION (Structural)		
<input type="checkbox"/> Excellent	<input checked="" type="checkbox"/> Good	<input type="checkbox"/> Fair
<input type="checkbox"/> Deteriorated	<input type="checkbox"/> Excellent	<input checked="" type="checkbox"/> Good
	<input type="checkbox"/> Fair	<input type="checkbox"/> Deteriorated

116 Keeney Street is a substantial two-story (late) Greek Revival-style frame residence with a gable roof, oriented with the gable end to the street. The structure rests on a stone foundation and is sheathed with wood shingles. The building incorporates an offset entry (left) and window sash is of 6/6 configuration arranged in a two-bay facade. Architectural features include a large two-story gabled wing on the left, pedimented gable in the street facade, and shed-roofed entry porch at the rear/left.

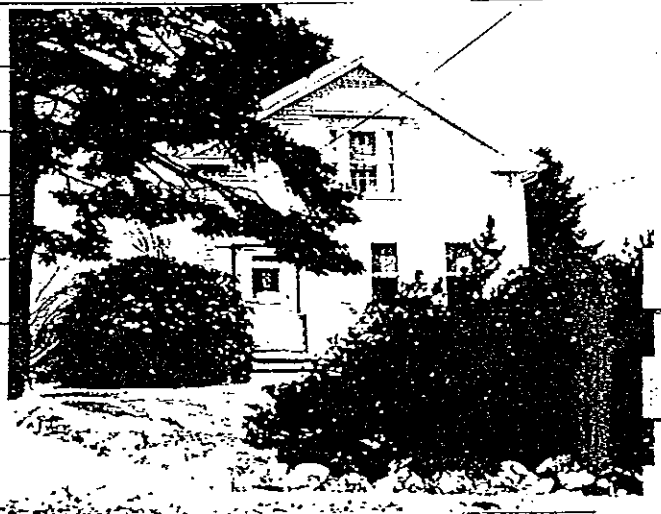
PHOTO

11. NUMBER OF STORIES 1-1/2	APPROXIMATE DIMENSIONS 22' x 28' plus addition		
12. CONDITION (Structural)		(Exterior)	
<input type="checkbox"/> Excellent	<input checked="" type="checkbox"/> Good	<input type="checkbox"/> Fair	
<input type="checkbox"/> Deteriorated	<input type="checkbox"/> Excellent	<input checked="" type="checkbox"/> Good	
<input type="checkbox"/> Deteriorated	<input type="checkbox"/> Fair	<input type="checkbox"/> Deteriorated

210 Keeney Street is a modest 1-1/2-story Greek Revival-style frame cottage with a gable roof, oriented with the gable end to the street. The structure rests on a stone foundation and is sheathed with replacement vinyl siding. The building incorporates an offset entry (left) with prominent pilaster-and-lintel surround. Window sash is of 1/1 configuration. Architectural features include a central chimney, eaves returns, enclosed entry porch on the left, gabled single-story ell, small frieze windows in the long elevations, and three-part window in the gable peak.

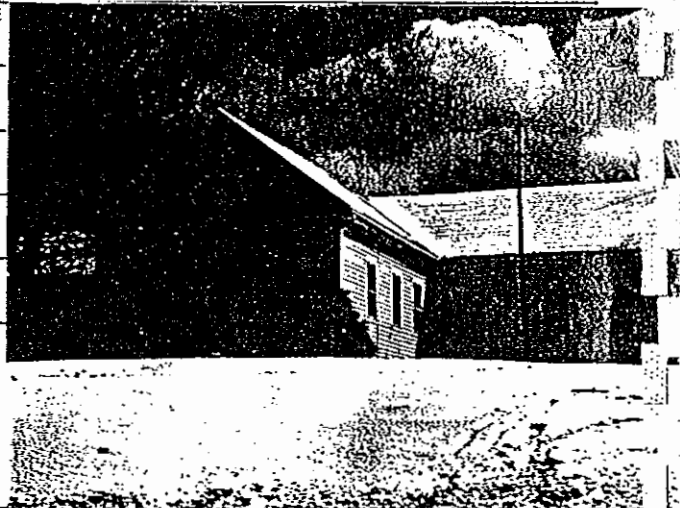
321 Keeney Street is a lovely 1-1/2-story Greek Revival-style residence (former schoolhouse) with a gable roof, oriented with the gable end to the street. The structure rests on a fieldstone foundation and is sheathed with clapboards. The building incorporates a central entry with pilaster-and-lintel surround. Window sash is of mixed 6/6, 4/4, and 6-light configuration. Architectural features include a molded pedimented gable, wide Doric corner pilasters, and large single-story gabled wing on the right.

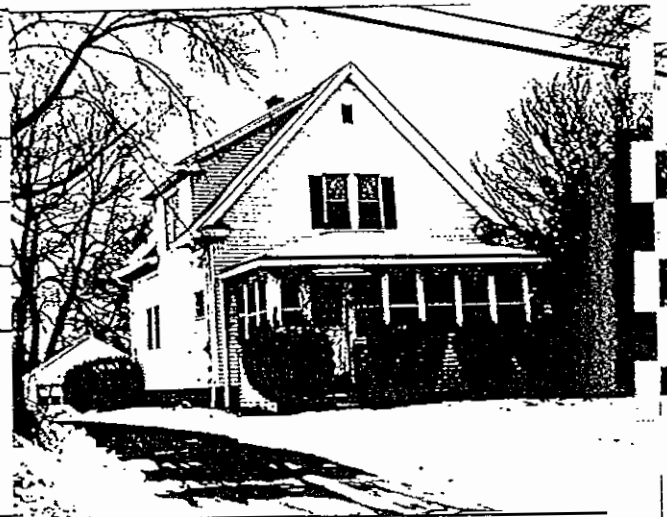
<input type="checkbox"/> Excellent	<input checked="" type="checkbox"/> Good	<input type="checkbox"/> Fair	<input type="checkbox"/> Deteriorated	<input type="checkbox"/> Excellent	<input checked="" type="checkbox"/> Good	<input type="checkbox"/> Fair	<input type="checkbox"/> Deteriorated
------------------------------------	--	-------------------------------	---------------------------------------	------------------------------------	--	-------------------------------	---------------------------------------

346 Keeney Street is a simple 1-1/2-story vernacular frame residence with a gable roof, oriented with the gable end to the street. The structure rests on a poured concrete foundation and is sheathed with replacement vinyl siding. The building incorporates an offset entry (left) and enclosed full-width hip-roofed porch. Window sash is of 1/1 configuration. Architectural features include shed dormers on the left and right and simple eaves returns.
